Effectiveness of Groundwater Cleanup Efforts at Pantex – the Southeast Contaminant Plume

STAND
Technical Report 2008-3

Prepared for STAND

November 2008

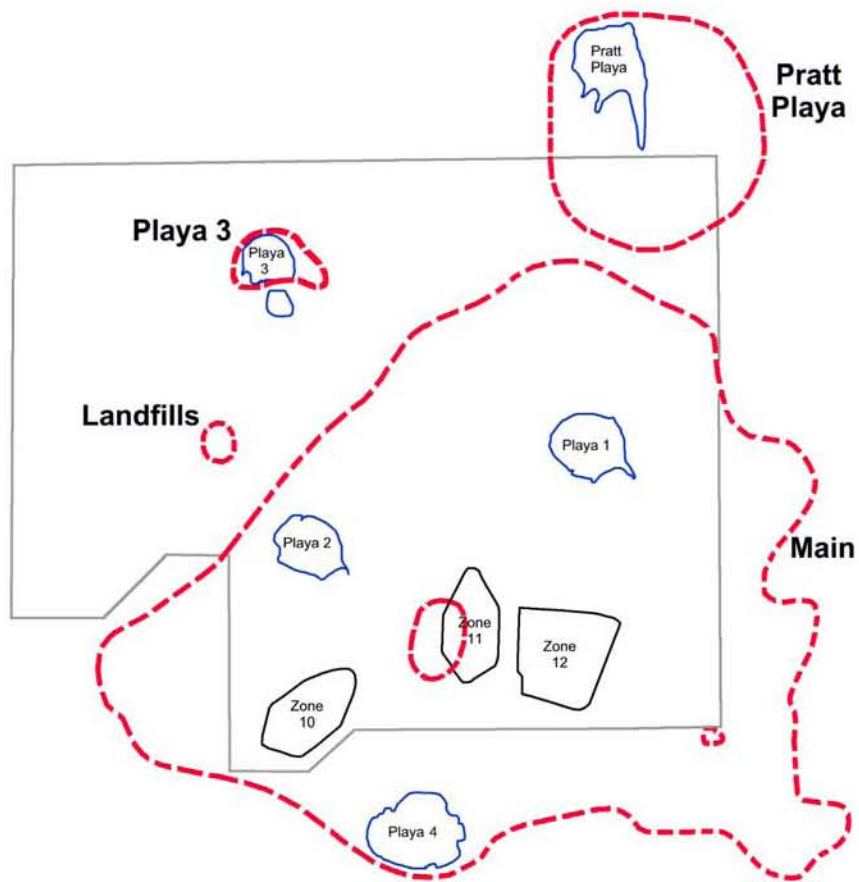
Figure 2.2
Bodies of Perched Groundwater

The perched aquifer does not exist beneath all of Pantex. There are at least four bodies of perched groundwater (figure 2.2)¹²: 1) groundwater associated with landfills in the west-central portion of the plant, 2) groundwater associated with Playa 3 in the northern portion of the plant, 3) groundwater associated with Pratt Playa in the northeastern portion of the plant, 4) the main body of perched groundwater. The main body extends across approximately 11 square miles in the central, southern, and southeastern portions of the plant. It also extends offsite beyond the eastern and southern boundaries of the plant¹³.

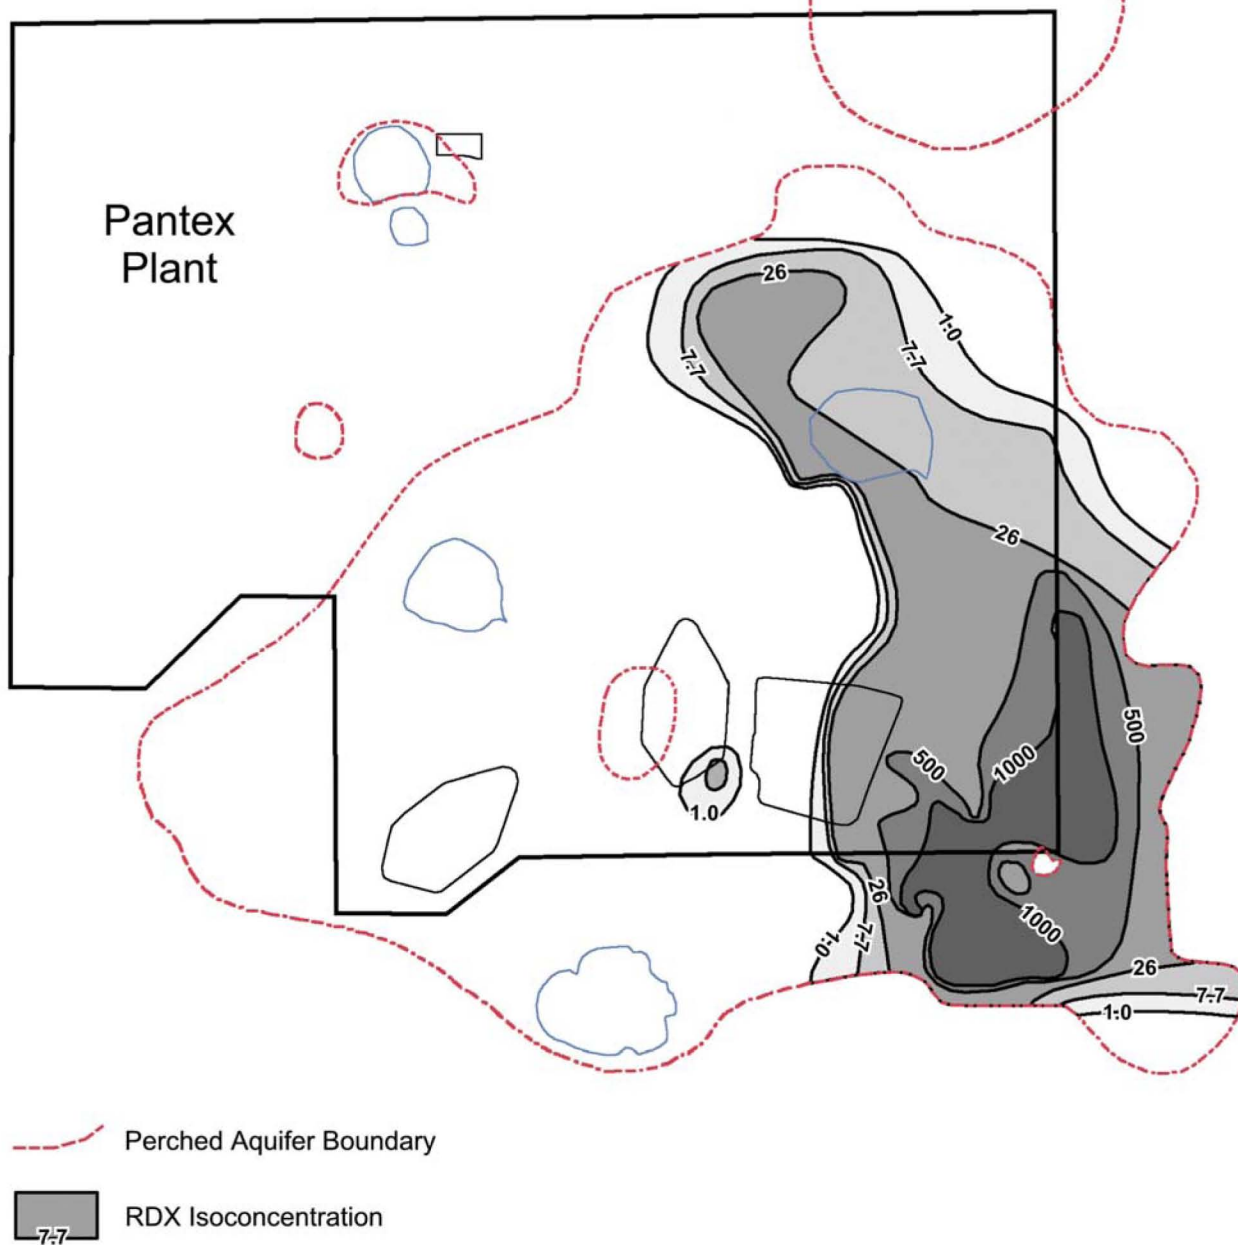
Figure 2.3
RDX in Perched Aquifer

Contaminants have been found in all four bodies of perched groundwater beneath Pantex (landfills, Playa 3, Pratt Playa, main)^{22, 23}. DOE distinguishes two zones of contamination within the main body of perched groundwater: the southeast zone, and Zone 11. The southeast zone covers Playa 1 and the area around Zone 12, including contaminated groundwater that has migrated beyond the plant boundaries to the east and southeast. Zone 11 covers a relatively small area near Zone 11. This report focuses on the southeast zone. RDX is the most widespread contaminant in the perched aquifer. The extent of the RDX plume is shown in figure 2.3.

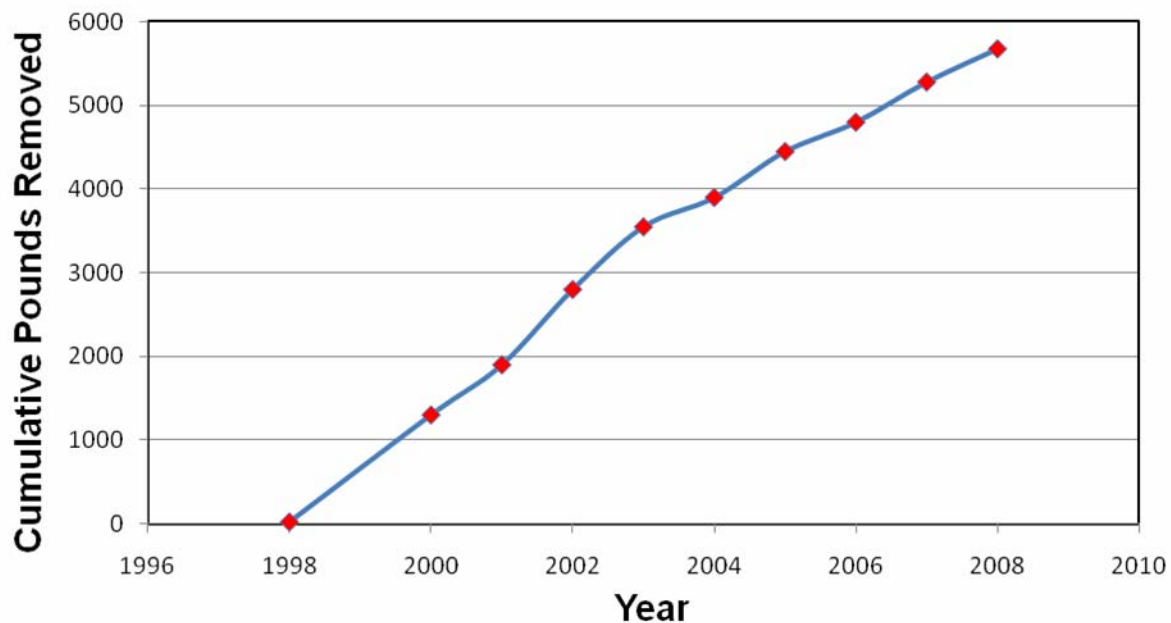
Figure B-1
Removal of High Explosives from the Southeast
Contaminant Plume

Through March 2008, approximately 5700 pounds of high explosives (e.g., HMX, RDX, TNT) have been removed from the southeast plume (figure 3.1)²⁶.

Overall, the treatment systems have been only marginally effective⁵⁰. Although approximately 5700 pounds of high explosives have been removed since 1995, this is a relatively small portion of the 95,000 pounds of RDX that DOE estimates is present in the perched aquifer and vadose zone.
